Address 84 Maple Street

Historic Name Robert and Claire Ryder House

## BUILDING FORM (84 Maple Street)

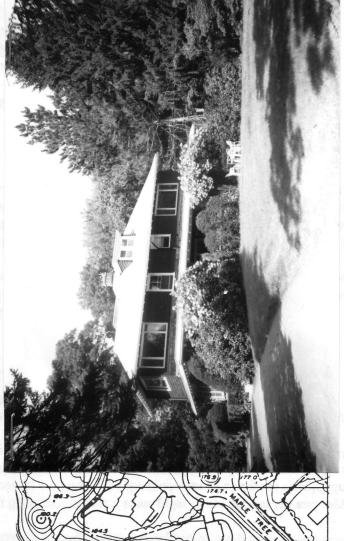
A variation on the Craftsman style, 84 Maple Street is a two-story dwelling sheathed in wood shingles above a fieldstone first floor. The building is capped by a hip roof which exhibits eaves which are slightly flared and adorned by exposed rafters. An officenter hip dormer rises from the front roof slope. Largely, obscured by rhododendrons, the first floor of the facade is fronted by a single-story, hip-roofed porch which is supported by stone posts and also exhibits exposed rafters. The open porch extends beyond the east end of the house. Underneath the porch, the glass-and-panel door is decorated by a dentil molding and is flanked by two wide, full length sidelights. Also sheltered by the porch is a three-sided bay window with 2/1 sash. Windows on the ends of the second floor of the facade contain modern tripartite replacements which probably replace multilight casements which are still visible on the west end of the house. At the center of the second floor facade there are two 2/1 windows of different sizes.

Behind the main house block is a two-story ell which is also hip-roofed. At the rear is a modern, single-story addition sheathed in clapboards and capped by a hip roof. It was constructed in 1990 and is fronted by a large deck.

At the street there is a stone pillar about six feet tall and capped by concrete. A line of trees extends along the road. The house is set back from the road with an elongated circular driveway located to the west of the house. At the end of the driveway is a single-story, wood-shingled garage capped by a flat roof and currently in poor condition. The property originally included 1.65 acres but has been reduced to 41,848 square feet.
